Debris/Ice/TPS Assessment And Photographic Analysis For Shuttle Mission STS-28R

September 1989

DEBRIS/ICE/TPS ASSESSMENT
AND
PHOTOGRAPHIC ANALYSIS
OF
SHUTTLE MISSION STS-28R

AUGUST 8, 1989

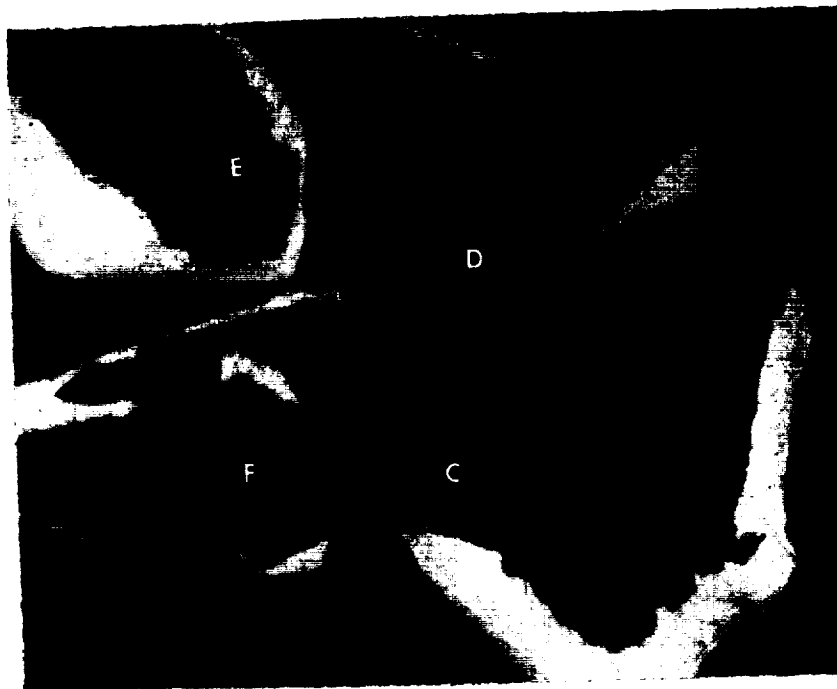
2.2.2 Figures 3 is low magnification OM photomicrograph of tile fragments from sample #2 to show the areas of analysis and the depressed surface. Figure 4 is high magnification OM photomicrograph of area C in Figure 3 to show the white clear fused silica.

FIGURE 3. LOW MAGNIFICATION OPTICAL
PHOTOMACROGRAPH OF SAMPLE #2 TO SHOW THE AREAS OF
ANALYSIS. 1X
